Weekly Report

Report # 18

# Norway House Cree Nation

- CD3 – Professional Accommodations

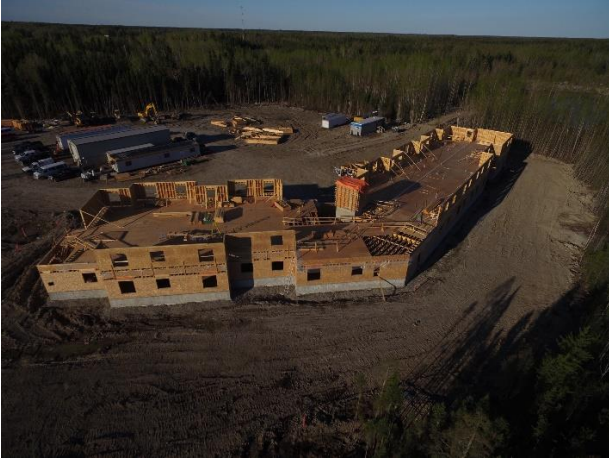
Overhead View

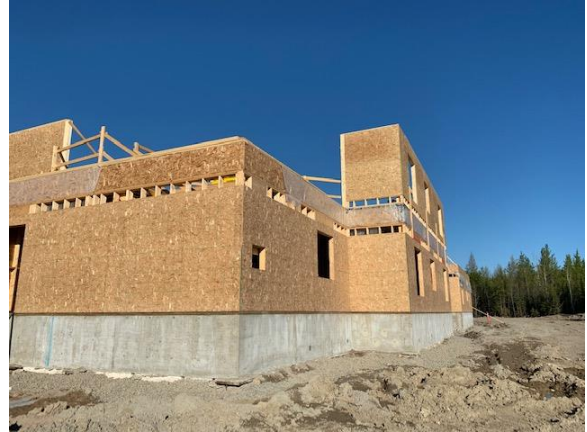
Exterior View – North East Side

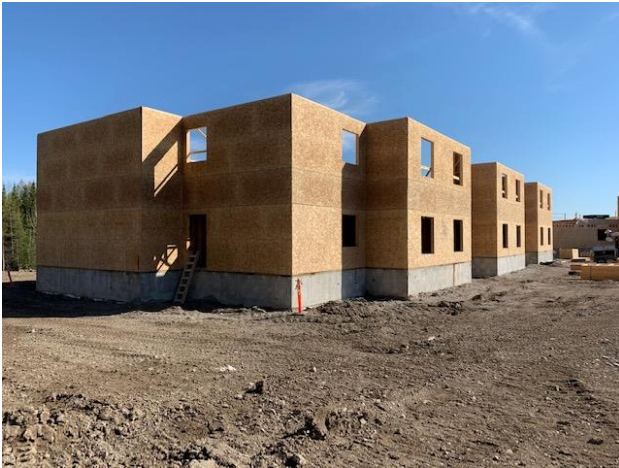
Exterior View – South West Side

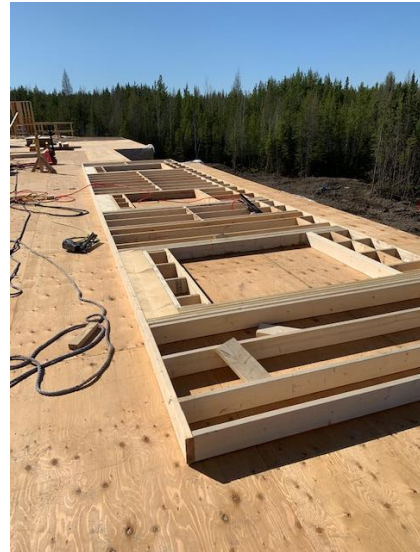
Second Floor Exterior Wall Framing  
– North East Side

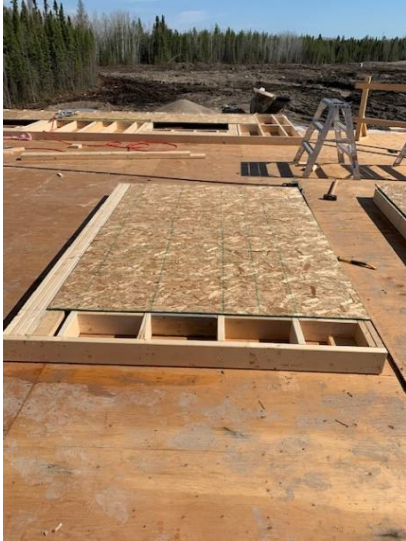
Second Floor Exterior Wall Sheathing  
-North East Side

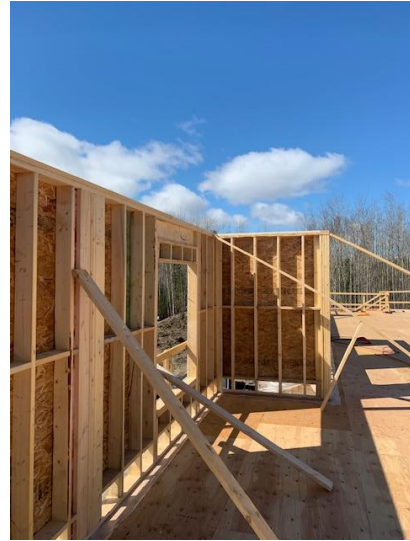
Second Floor Exterior Walls  
-South East Side

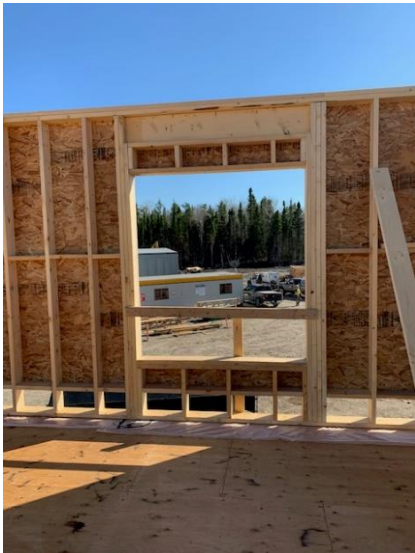
Second Floor Exterior Window  
– South East Side

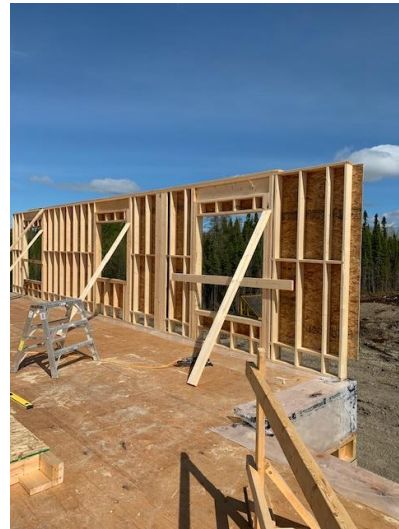
Second Floor Exterior Wall  
– North East End

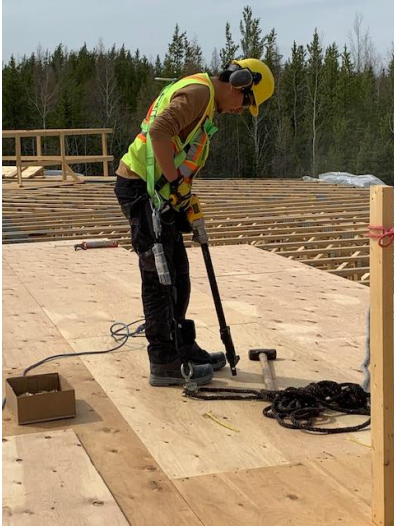
Second Floor Sheathing Install  
- North East Side

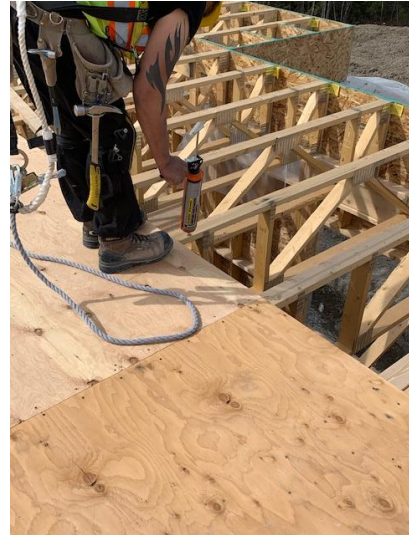
Sub Floor Adhesive Applied  
-North East Side

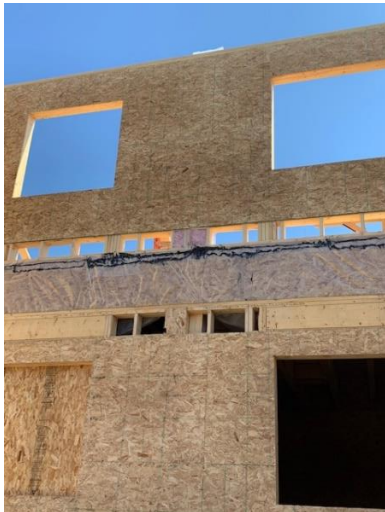
Vapour Barrier Rim Board Detail  
-South West Side

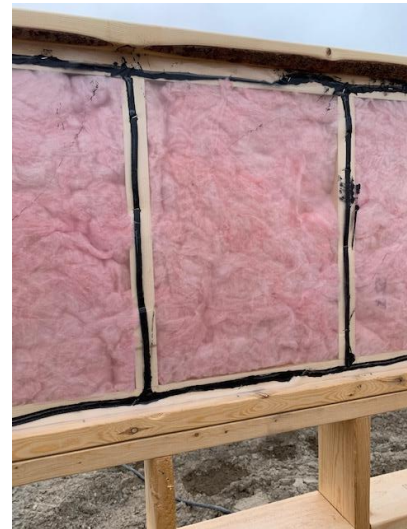
Insulation and Vapour Barrier  
On Rim Board -Second Floor Stair 2 East Side

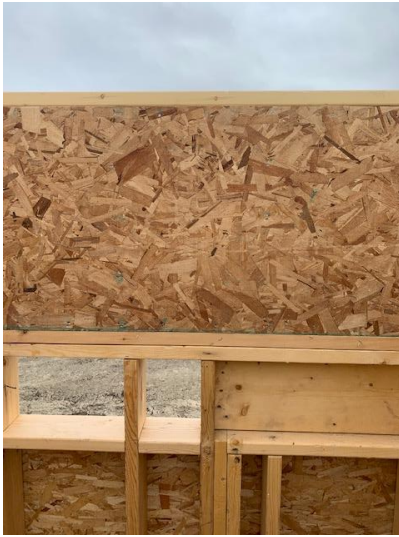
Interior Sheathing Install on Rim Board  
- Stair 2 East Side

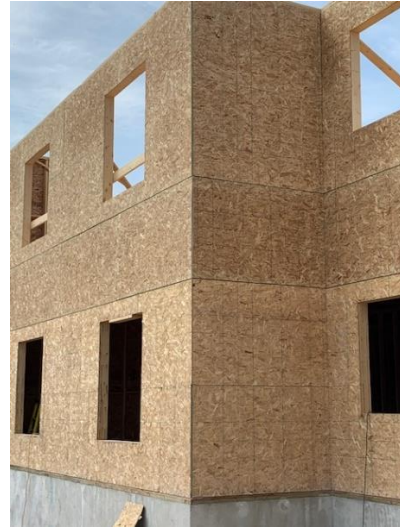
Exterior Sheathing Install  
Between Main and Second Floor

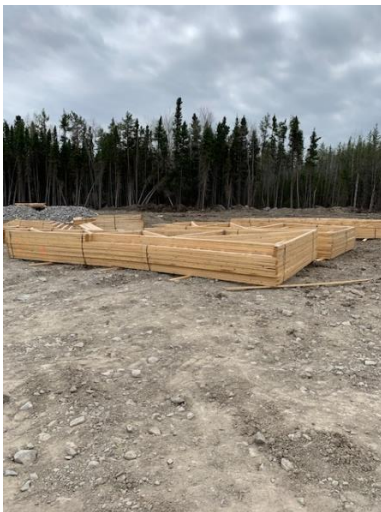
Roof Trusses on Site

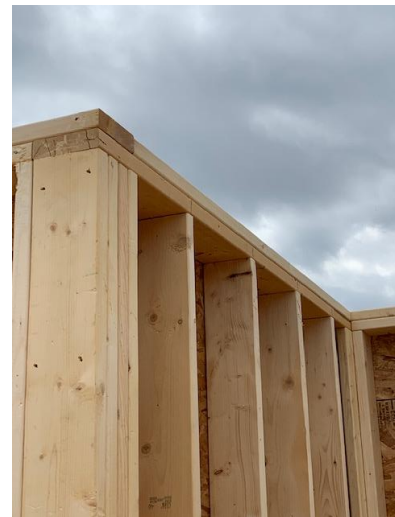
Double Top Plate Installation  
On Exterior Wall – South East End

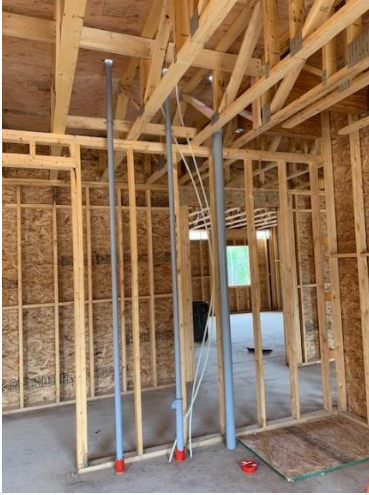
Sanitation and Domestic Water Lines  
To Second Floor

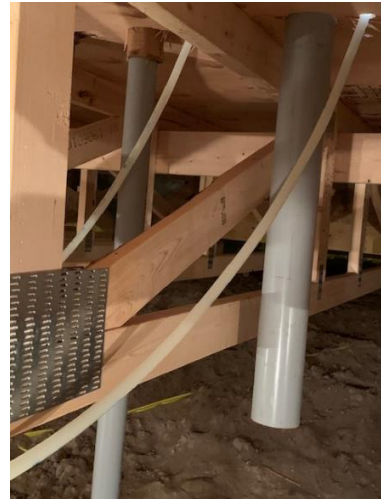
Sanitation and Domestic Water Lines  
In CrawlSpace

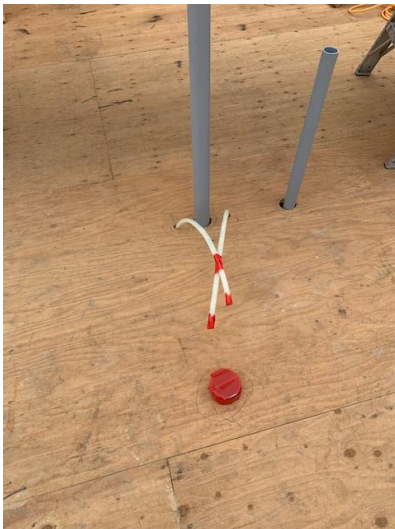
Sanitation and Domestic Water Lines  
Penetrated Second Floor

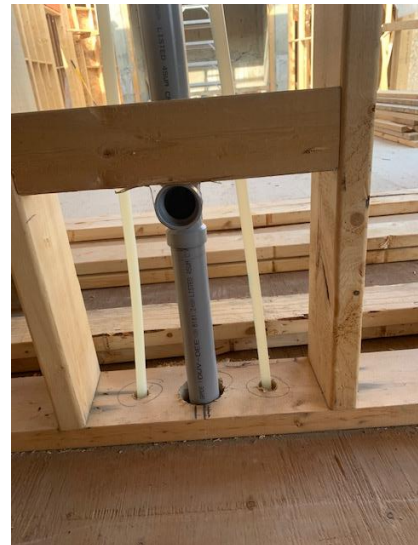
Sanitation and Domestic Water Lines  
With Bracing

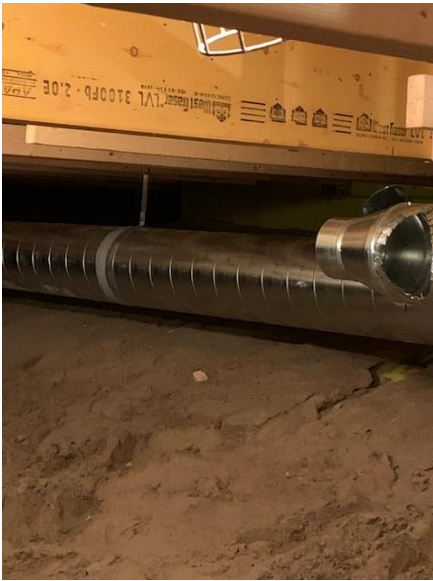
Duct Work Installation in Crawlspace

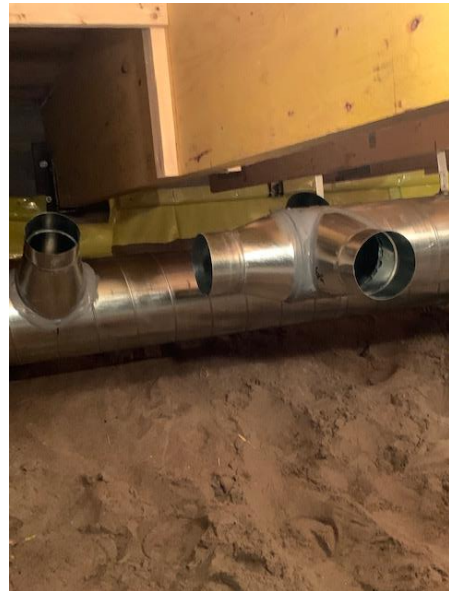
Duct Work Installation in Crawlspace

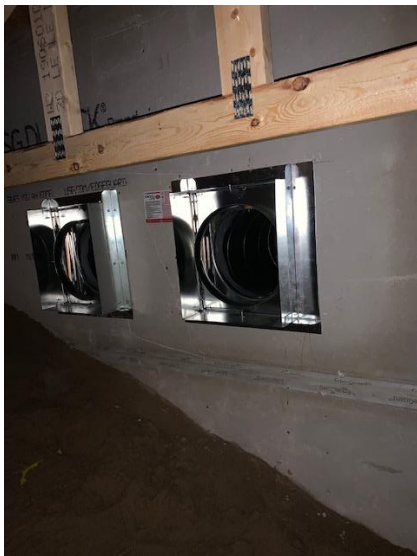
Duct Work Sleeves Installed in Fire Stop Wall in Crawlspace

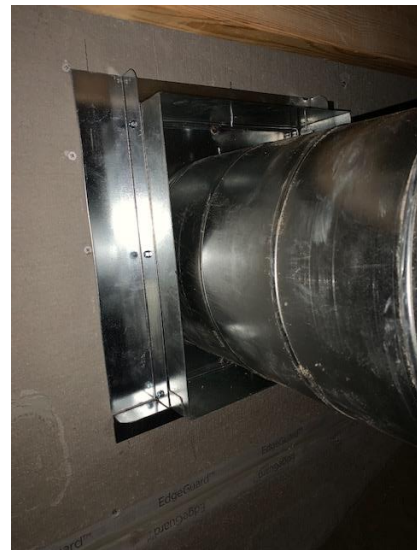
Duct Work and Sleeve Installed in Fire Stop Wall in Crawlspace
