**19-11-07 – Weekly Project Update #6**

**19015A – CD1 - Offsite Sewer and Water**

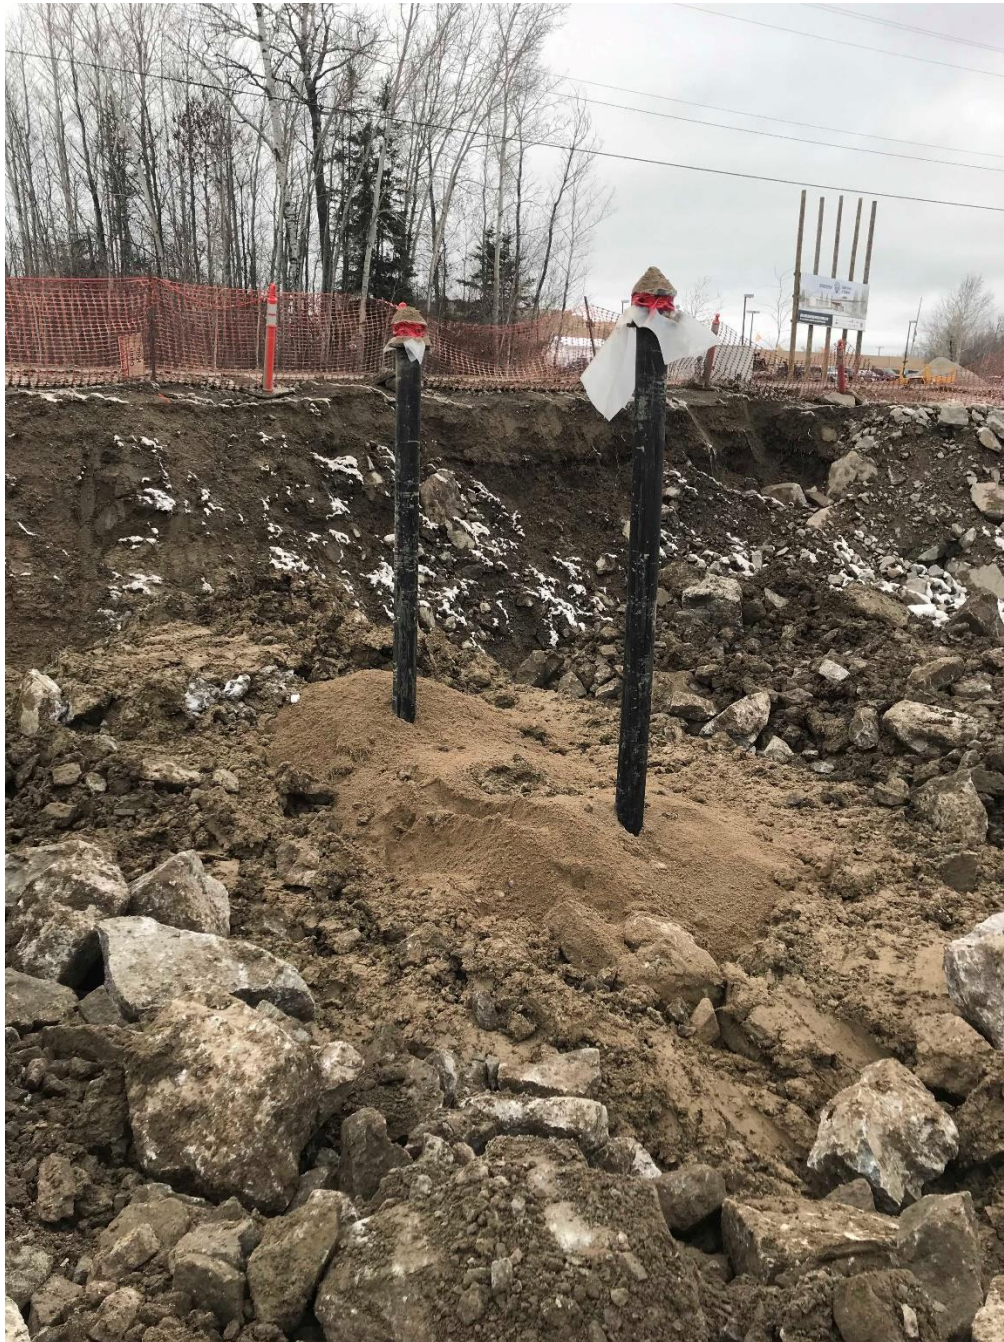
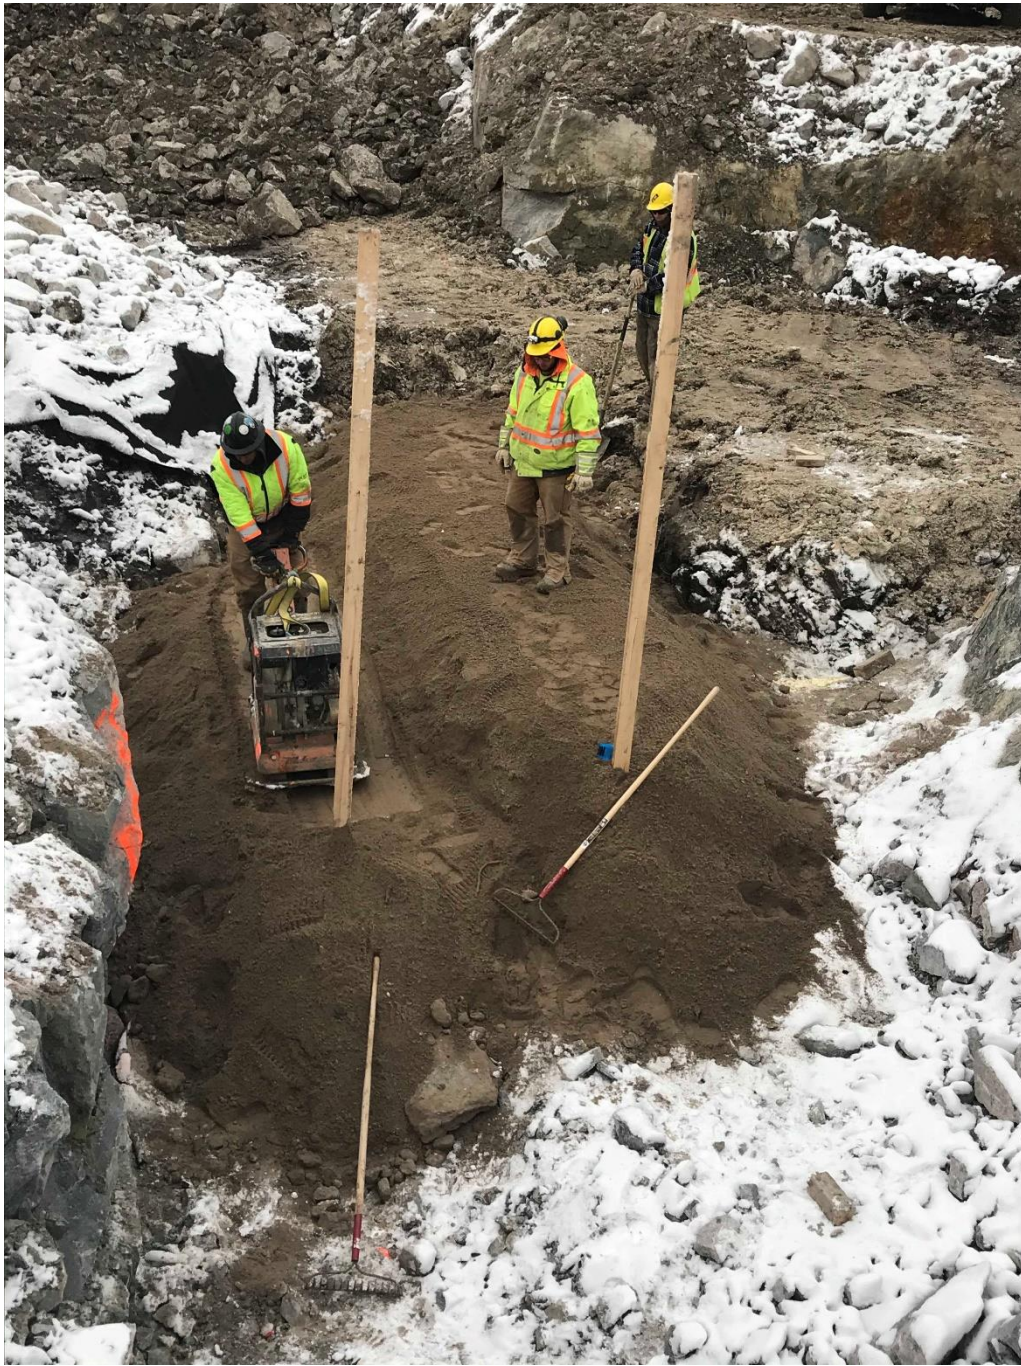
Work continued on the offsite sewer and water with work getting close to being completed. Valves were installed on the extensions of the force main and water main running parallel along Jack River Road. These can be seen below. Sand was placed and compacted with valve stem and markers installed.

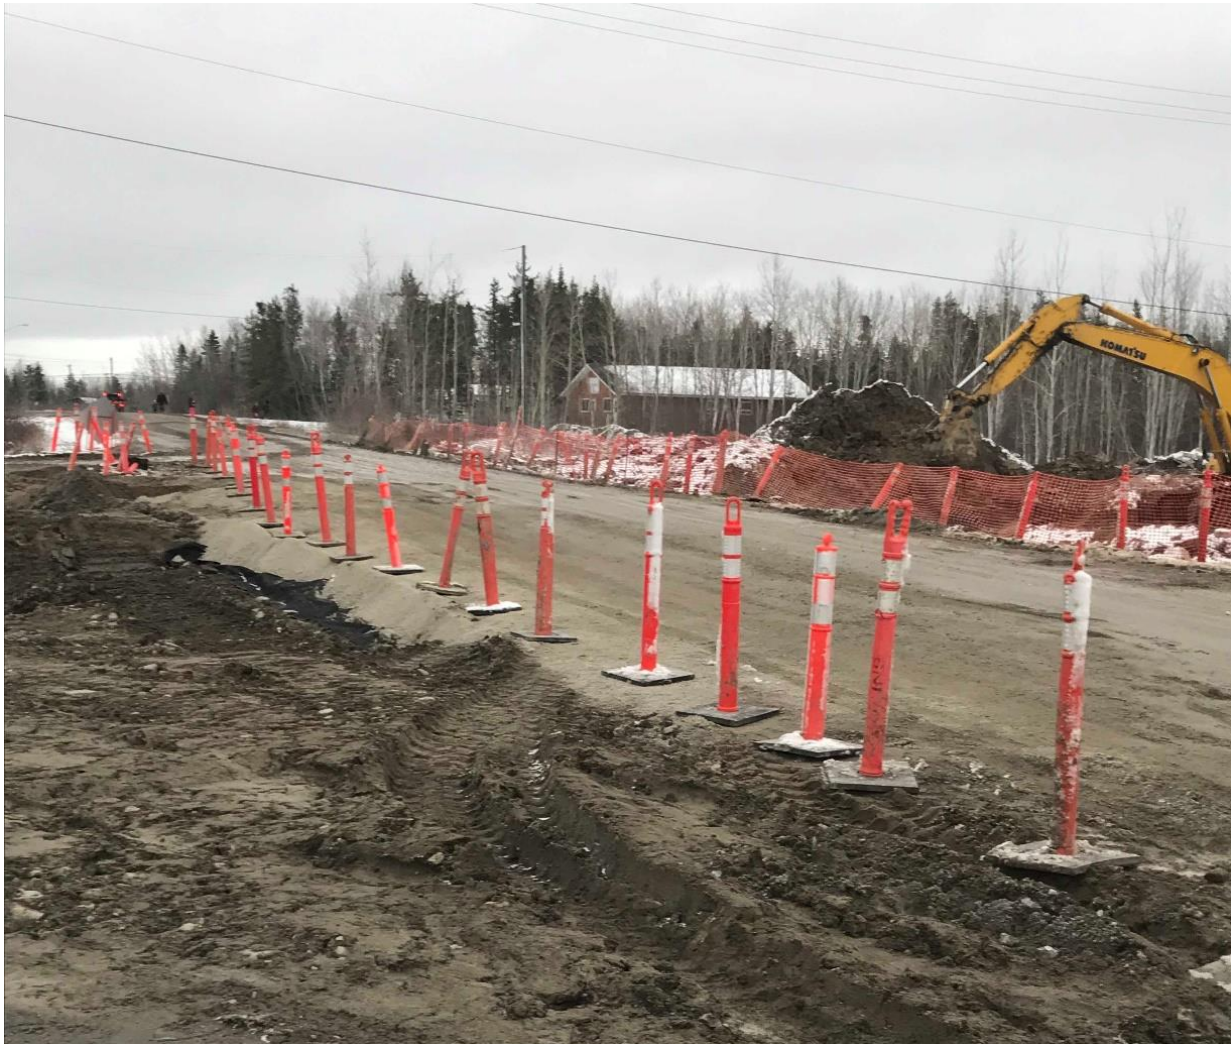
As the road crossing was previously re-established and detour removed it was actively maintained to ensure that there wasn't any rutting or potholes in the reestablished road. The road is currently still delineated and will remain that way until construction activities are complete.

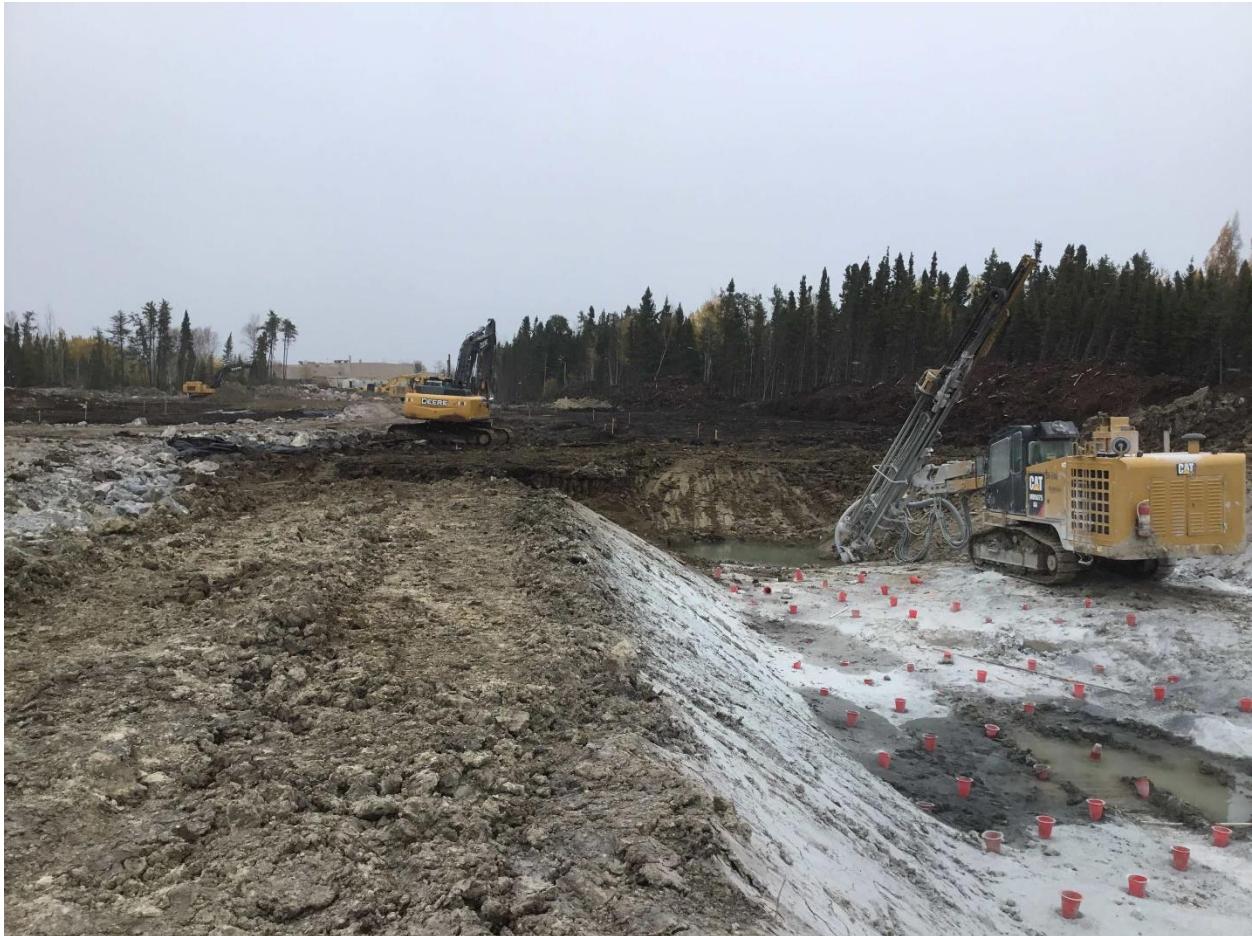
As mentioned last week the quarry continues to be pumped down and discharged into the low areas away from the project site. This operation will continue until the quarry is sufficiently drained or pumping operations cease due to freezing conditions. Last week it was stated that the drilling and blasting was completed however some additional areas of high rock were encountered and additional trench blasting was required to be completed. This area of high rock was located in the force main trench in front of the new Health Centre of Excellence and didn't interfere with any of the other work occurring onsite or delay any of the piping installation.

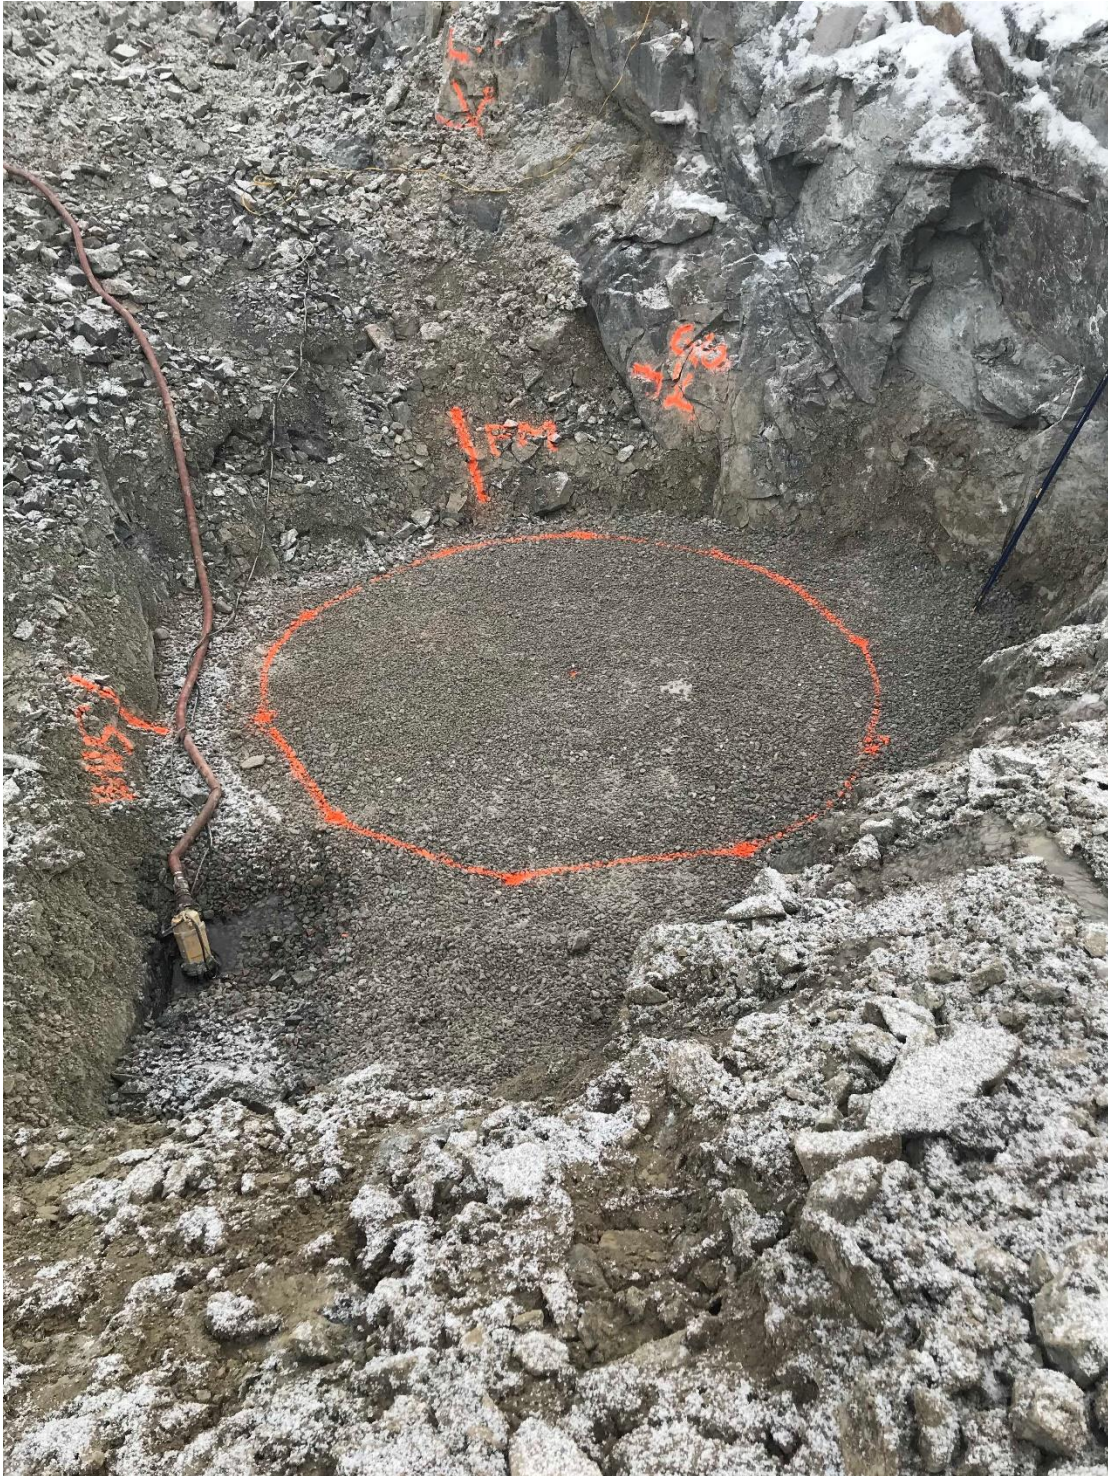
In preparation for the onsite lift station to be installed pipe alignments are marked on the rock and sumps are prepped in the event that ground water becomes an issue. The level compacted granular pad for the lift station base can be seen below.

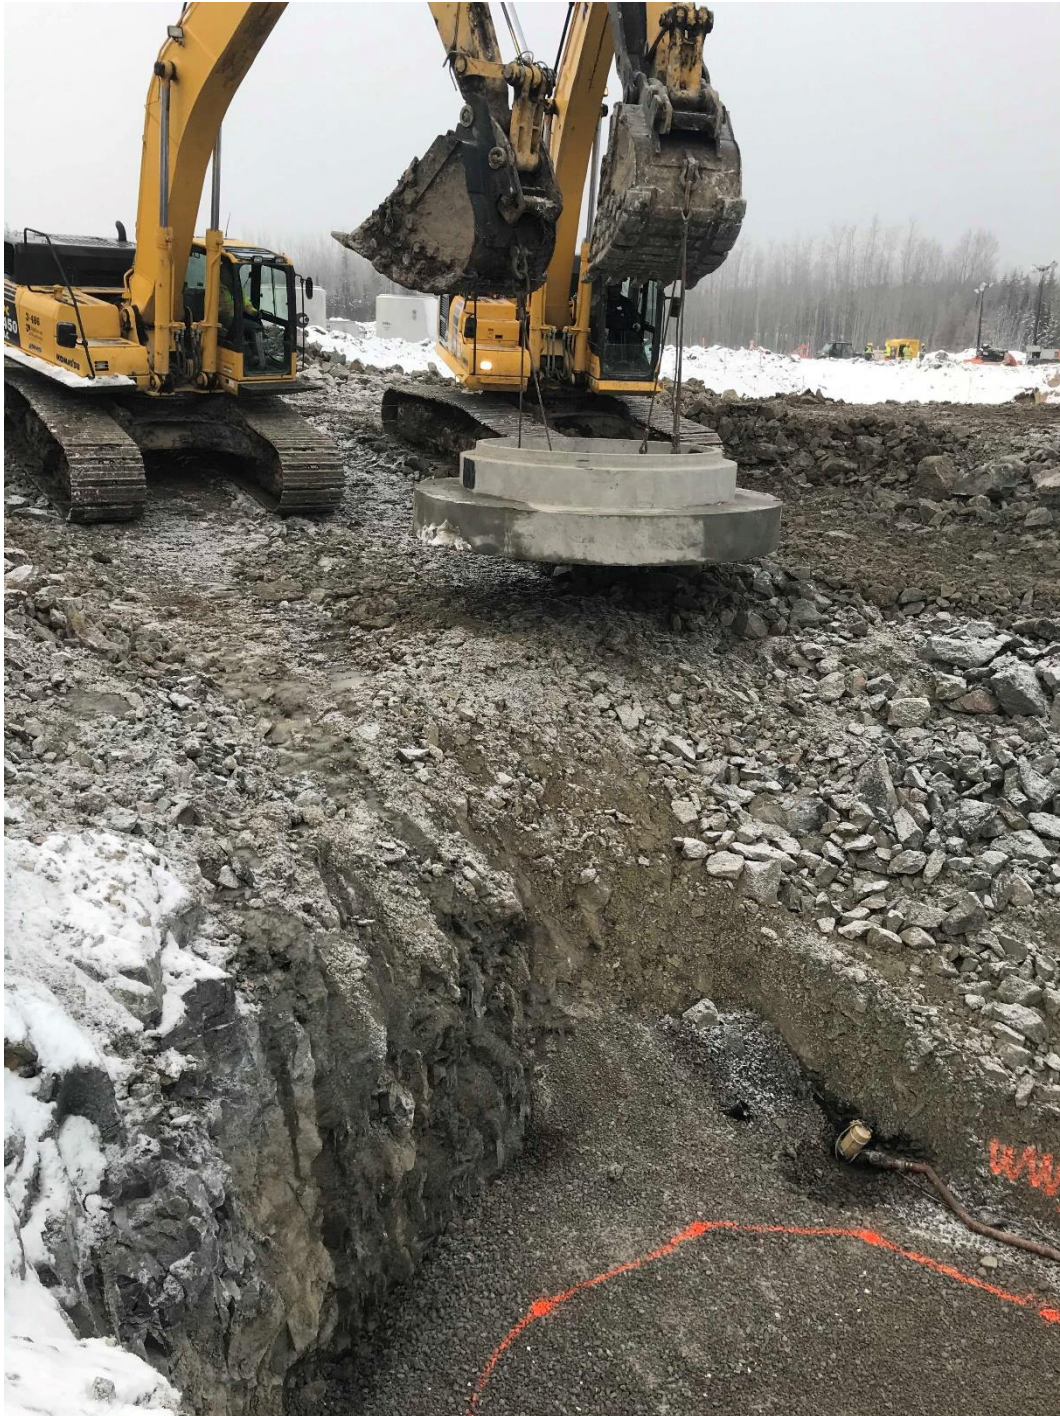
Due to the size of the onsite lift station a tandem lift was required. Prior to this task being completed a JSA as completed and all workers completed a specific FLHA. As is the case with all lifts no equipment or persons was to enter the area below any suspended loads.

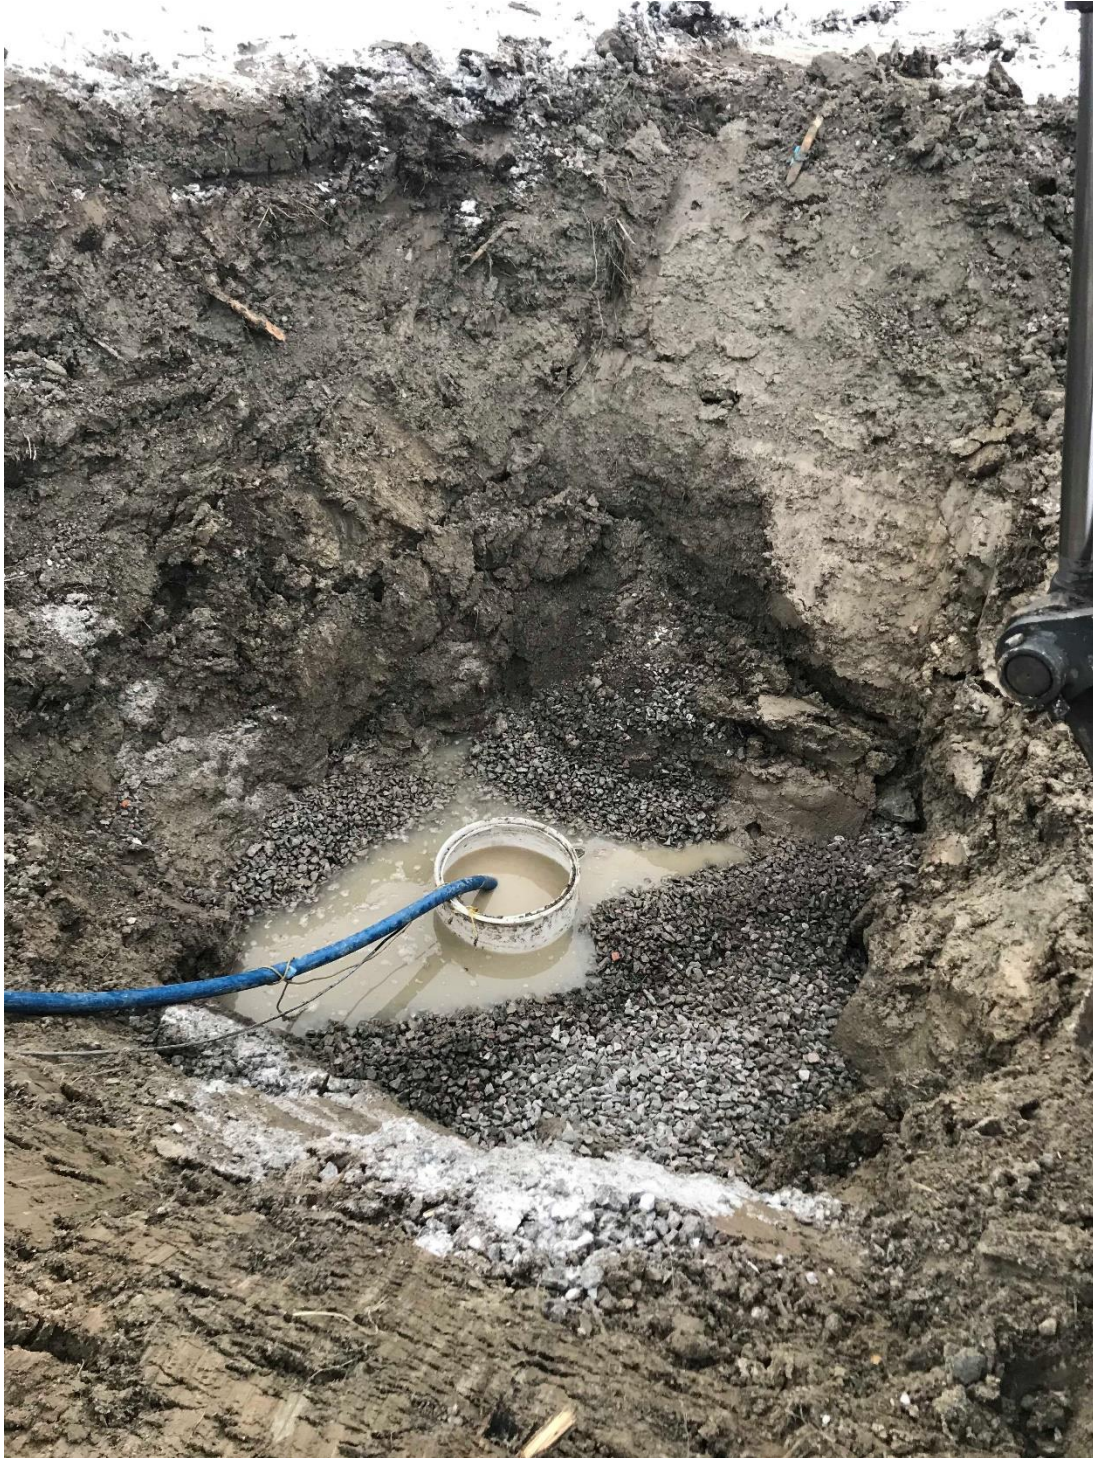
At certain locations along the pipe alignment installation significant amount of ground water was encountered. To manage this a sump was dug and a barrel surrounded by clean stone was installed. This clean stone and barrel allowed for the water to enter and not the mud and sediment allowing the pump to continuously dewater.

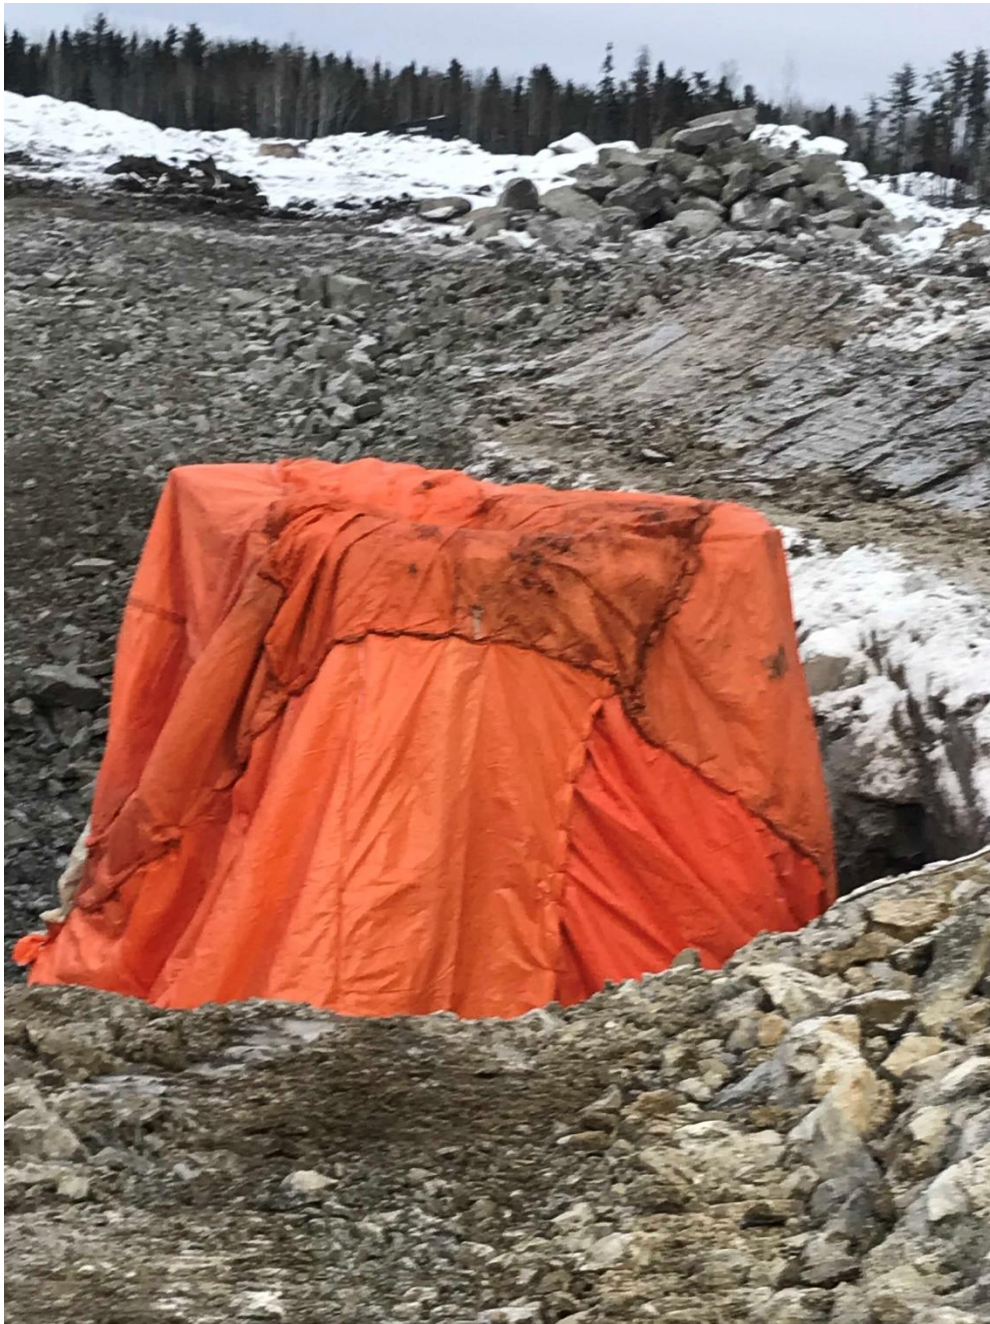
As lift station sections and manholes are installed, they are required to be insulated and heated to allow the sealing grout to set appropriately. This needs to be completed prior to the manhole sections being backfilled and can be seen below.
